Memorandum

Surface Water Runoff Event – Surface Exploration Drilling

Date: 12 February 2015

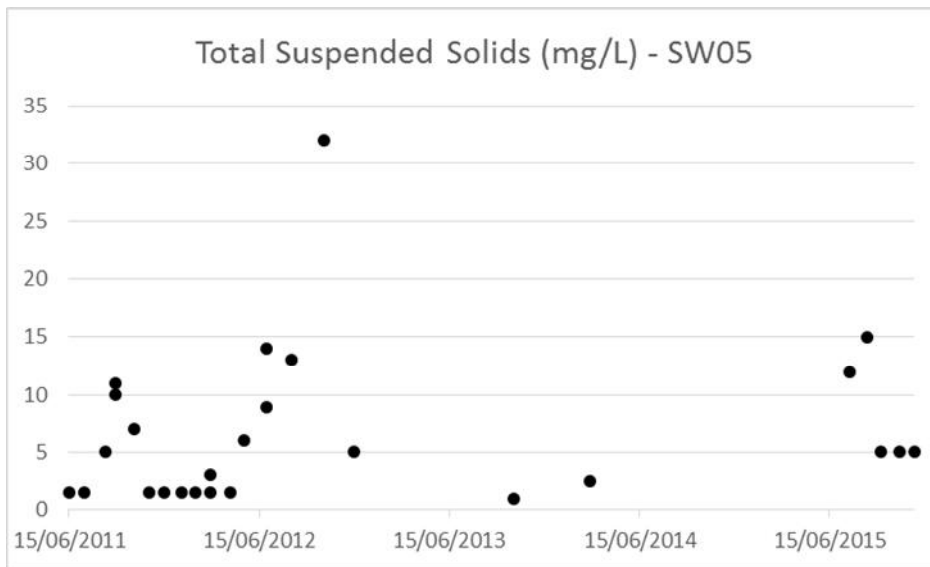
DGL have also been carrying out environmental baseline monitoring in the catchment as a whole, and have been developing an understanding of baseline conditions with respect to surface water quality. Our total suspended solids data for the Owenkillew River from location SW05 is presented as a function of time on the graph below. It can be observed that suspended solids loading in the Owenkillew upstream of DGL operations fluctuate, and that they can readily exceed values of greater than 10 mg/L. Therefore, the measured suspended solids concentration in the Owenkillew directly following the incident fits entirely within the range of background conditions. There is considered to have been no discernible impact upon the Owenkillew River.

NB: Values below detection limit have been graphed as half the detection limit

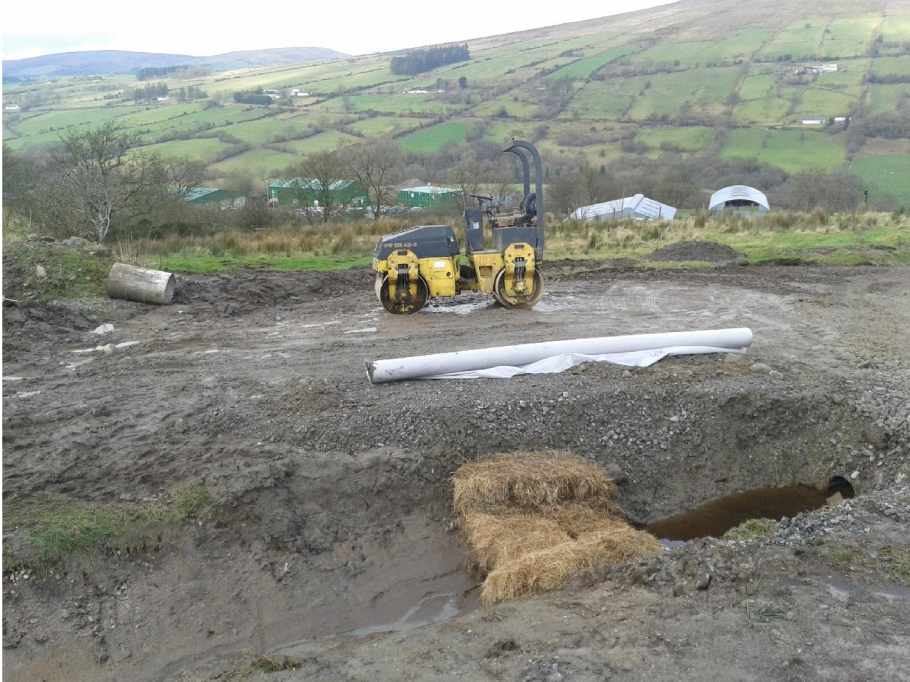
Photo 1: Unblocked drain

Approximate timing	Preventative action
Friday 5th	
13:00	SF identifies blocked drain adjacent to the track which is used to access some drilling pad sites. It is considered that the drain became blocked during on-going demobilization and rehabilitation activities and was no longer able to divert runoff from the track (exposed ground). SF arranges for unblocking of drain (Photo 1), and further action plan is formulated to mitigate against any potential re-occurrence of incident.

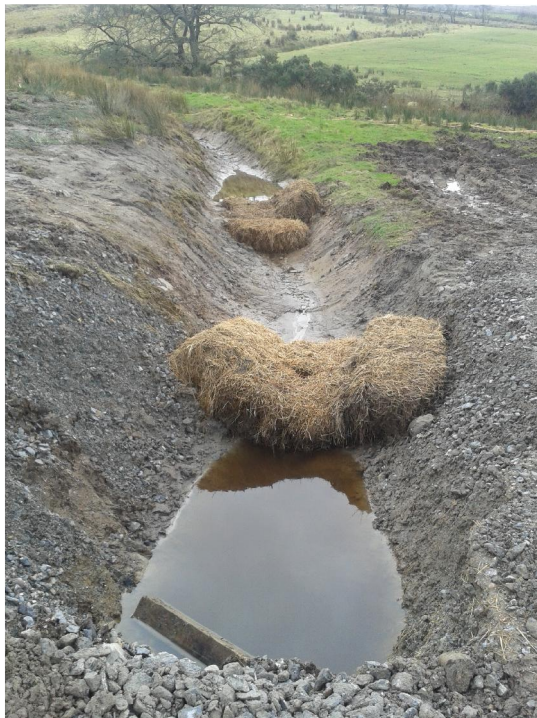
**Photo 2:
Temporary
sumps**

13:00	Contractor mobilized to install temporary sumps in ditches leading from drill program site (see Photo 2). As a temporary measure Drinking Water Inspectorate approved floc blocks are positioned prior to sumps. Hay bales located after sumps for final solids removal.
Sunday 7th

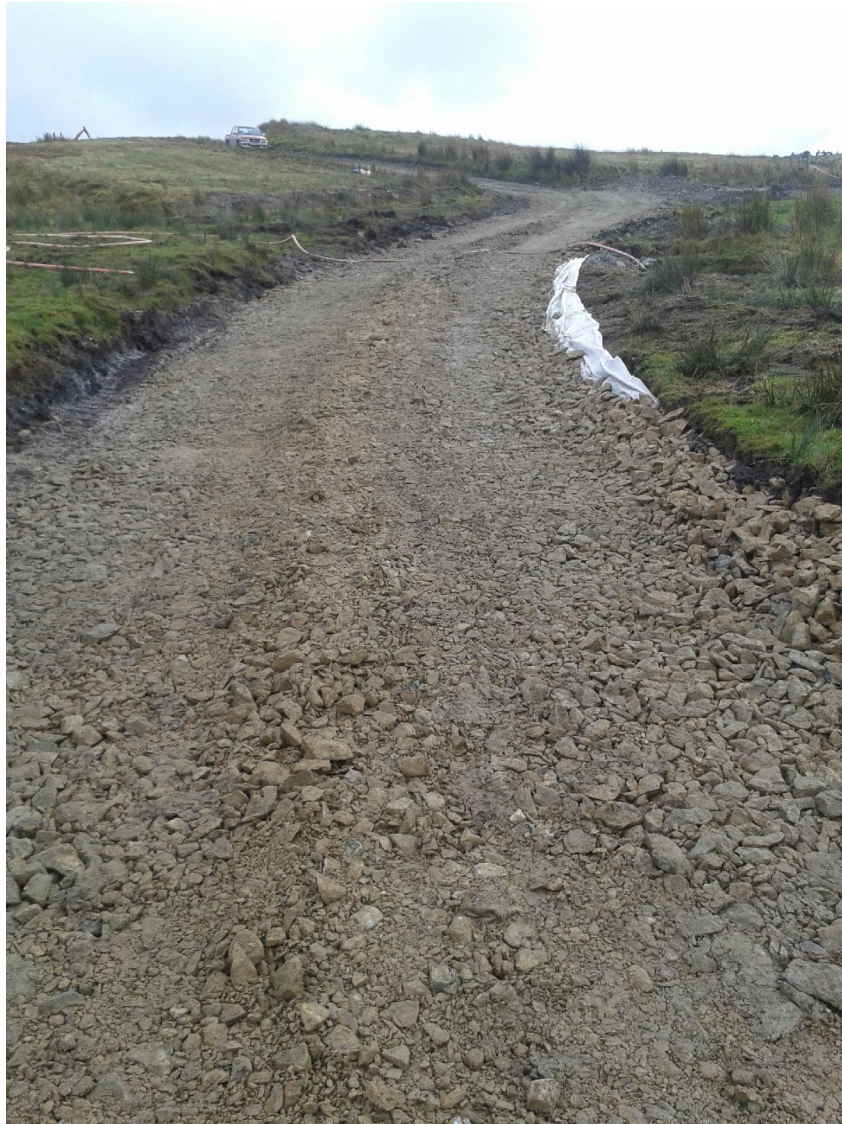
**Photo 3:
Resurfaced
Track**

Tuesday 9th	
11:00	Work commenced to fully upgrade surface of existing access track with geotextile cover and fresh gravel (see Photo 3) to minimize the amount of exposed ground ¹ . Plan includes for resurfacing approximately 450m of track (marked blue on Figure 1) to be completed by 13 February.
12:30	Full traffic ban reduced to restricted traffic flow only. No heavy vehicles allowed.
Wednesday 10th	
07:00	Restricted traffic flow lifted to light vehicles only. Exception made for vehicles undertaking track improvements.
09:00	Continuation of track improvements.
11:00	DT revisits exploration drilling site for inspection. Conditions understood to be satisfactory.

- DGL have since been implementing a preventative active plan to ensure no reoccurrence. This plan has include resurfacing approximately 450m of track (with geotextile and fresh clean stone cover) and additional drainage improvements, together with the use of further temporary silt control enhance measures (e.g. sumps and bales). These temporary measures will be removed as the drilling program is full demobilized over the coming days; and
