Memorandum

Surface Water Runoff Event – Surface Exploration Drilling

Date: 12 February 2016

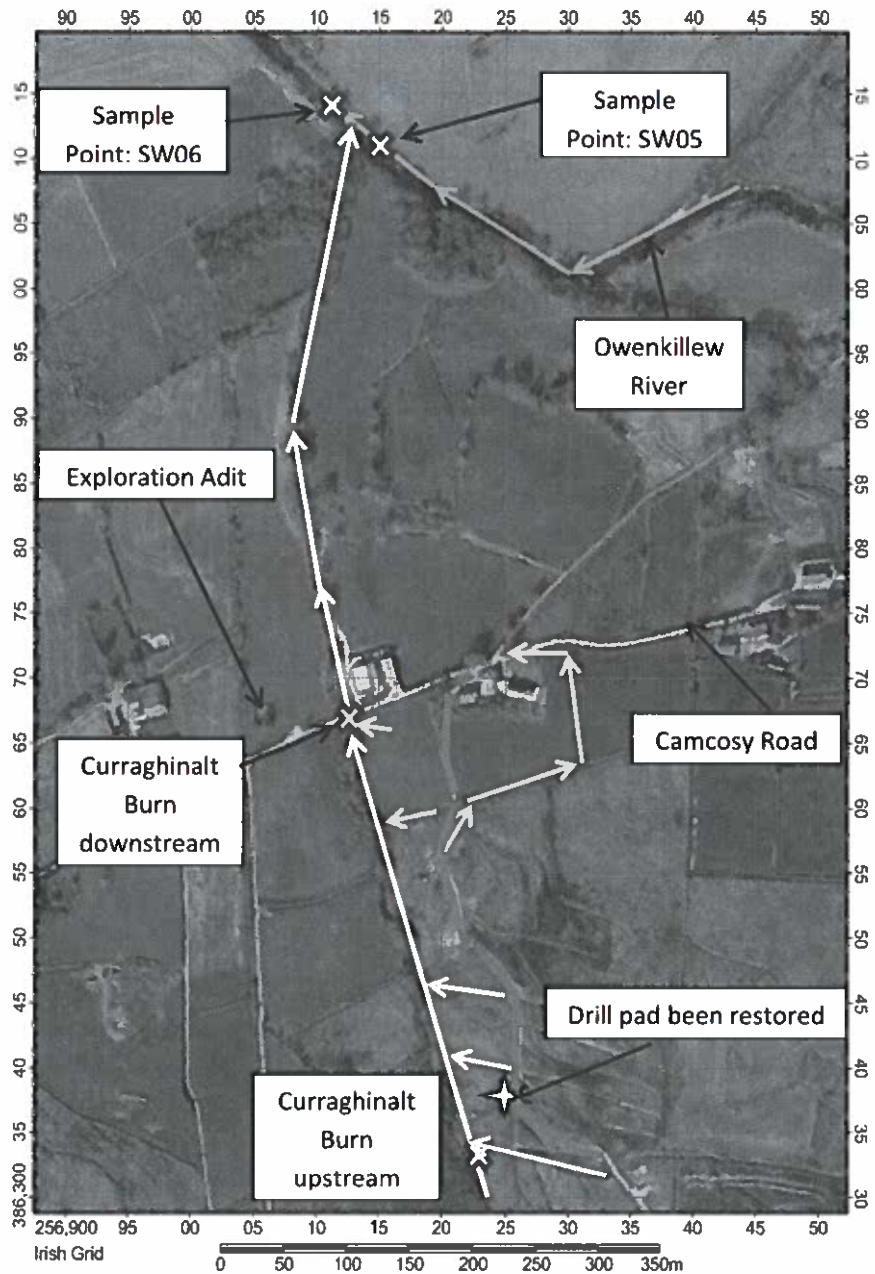
Figure 1: Site map (Bing Maps) showing surface water sample locations. Potential drainage channels from surface drilling program site are highlighted in yellow.

During the above sequence of events, DGL have collected and tested surface water samples for total suspended solids. Relevant laboratory certificates are attached. Sample results are presented below, together with locations referenced (Figure 1). It is understood that the NIEA also have separate analysis of the initial samples collected on 5 February.

Tuesday 9th	
11:00	Work commenced to fully upgrade surface of existing access track with geotextile cover and fresh gravel (see Photo 3) to minimize the amount of exposed ground ¹ . Plan includes for resurfacing approximately 450m of track (marked blue on Figure 1) to be completed by 13 February.
12:30	Full traffic ban reduced to restricted traffic flow only. No heavy vehicles allowed.
Wednesday 10th	
07:00	Restricted traffic flow lifted to light vehicles only. Exception made for vehicles undertaking track improvements.
09:00	Continuation of track improvements.
11:00	DT revisits exploration drilling site for inspection. Conditions understood to be satisfactory.

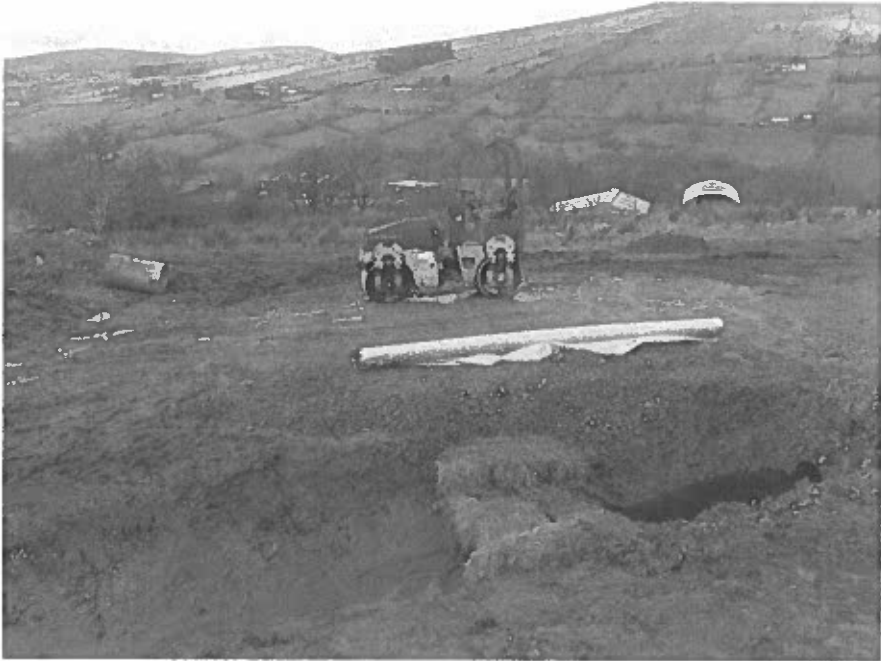
Photo 1: Unblocked drain

Approximate timing	Preventative action
Friday 5th	
13:00	SF identifies blocked drain adjacent to the track which is used to access some drilling pad sites. It is considered that the drain became blocked during on-going demobilization and rehabilitation activities and was no longer able to divert runoff from the track (exposed ground). SF arranges for unblocking of drain (Photo 1), and further action plan is formulated to mitigate against any potential re-occurrence of incident.

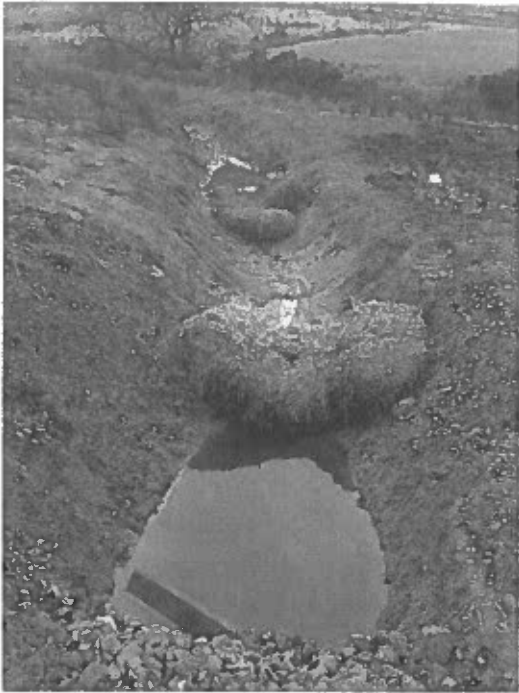
**Photo 2:
Temporary
sumps**

13:00	Contractor mobilized to install temporary sumps in ditches leading from drill program site (see Photo 2). As a temporary measure Drinking Water Inspectorate approved floc blocks are positioned prior to sumps. Hay bales located after sumps for final solids removal.
Sunday 7th

07:00	Restricted traffic flow continued. No heavy vehicles allowed.
12:00	Improvements made to temporary sumps.
Monday 8th	
07:00	Restricted traffic flow continued. No heavy vehicle allowed.

09:00	Further improvements made to temporary sumps to help ensure no re-occurrence.
10:00	Cut off trenches installed across access track to disperse rainfall to vegetated land.
